# Group B Project Report

## *Safe Drinking Water For Small Communities*

November 2003

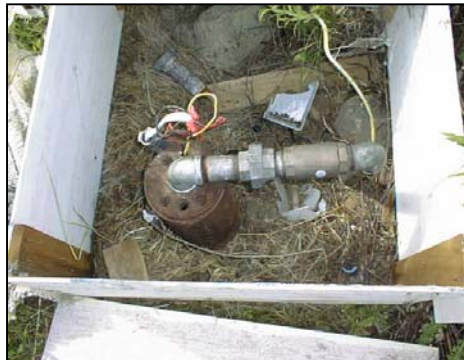
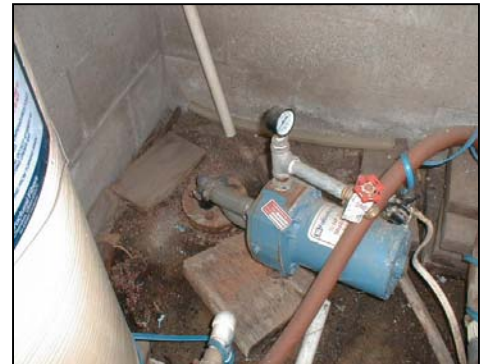
### ***Lack of properly constructed and screened well vents (53%)***

Proper venting is key to preventing contamination being drawn into the well. This deficiency coupled with the **lack of sealed well caps (21%)** means that a significant number of the targeted water systems in this project are subject to potential contamination of drinking water.

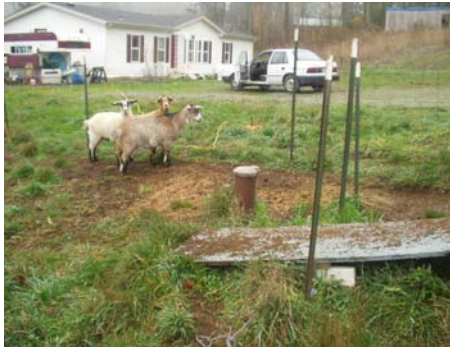
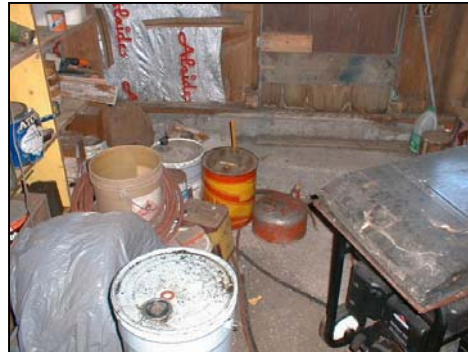
### ***Biological and chemical contaminants located within 100 ft. of source (31%)***

Potential sources of contaminants within 100 feet of a drinking water source pose a significant health risk to consumers through pollution of groundwater and ultimate contamination of drinking water. Frequently observed contaminant sources included manure piles, compost piles, livestock enclosures, grazing animals, septic tanks and drain fields, sewer lines, underground storage tanks, gasoline, propane, and diesel storage, liquid fertilizer, herbicides, pesticides, insecticides, and house paints.

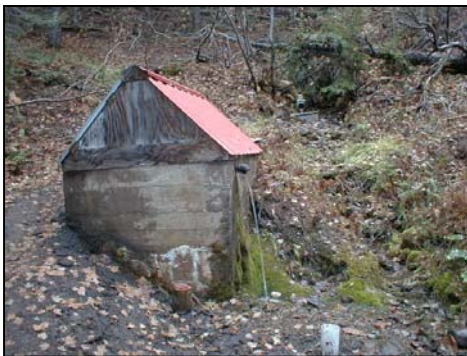
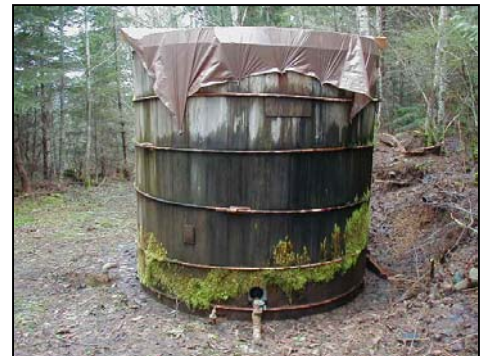
### ***Open storage reservoirs (~13%)***

Open storage reservoirs can be ready points of entry for contaminants (birds, bats, rodents, etc.) into the water system. While only 26 percent of the systems used non-pressurized atmospheric storage reservoirs, about 49 percent of these reservoirs had unprotected openings that could easily serve as points of entry for contamination. There have been cases of waterborne illness traced back to open storage reservoirs. In addition to unprotected openings, a wide variety of unacceptable storage tanks were found to be in use such as old wood tanks, preformed concrete tanks originally intended as septic tanks, and metal tanks that had not been intended for water storage

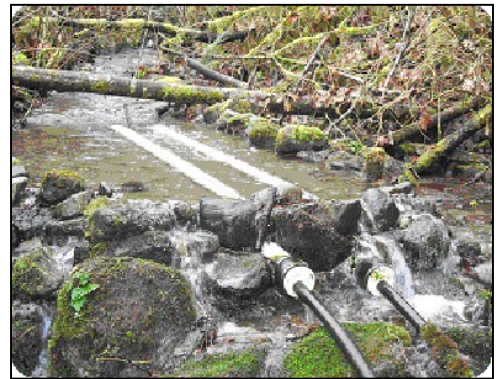
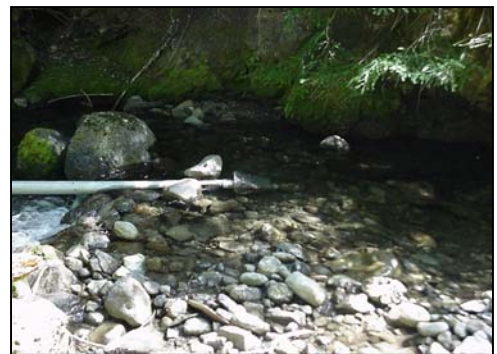
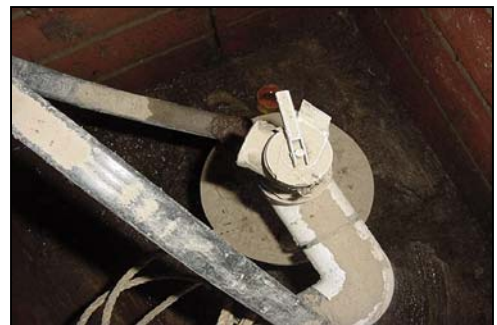
### ***Other unsafe conditions***

- Unsafe sources such as:
  - switching from a groundwater source to a highly vulnerable surface water (lakes, etc) source without approvals
  - shallow dug wells
  - surface water from creeks
  - poorly developed or unprotected springs which were often unfiltered and had no disinfection
  - unapproved sources / treatment systems in place
  - old inactive sources that continue to be connected to systems
- Absentee water system owners – no one in responsible charge of the water system
- Lack of knowledge and experience of water purveyors.
- Evidence of vandalism and a general lack of security
- Hazardous conditions in pump houses such as bare electrical wires, blocked access to water system components, and rodent infestations
- Known or obvious risk of wellhead contamination from flooding
